IMPORTANT PRODUCT INFORMATION

Product:	Control Version 2.20
	IC641CTL970K Control 90-70 Programmer w/CD Documentation
	IC641CTL971K Control 90-70 Programmer w/paper Documentation
	IC641CTL170K Control 90-70 Programmer Logicmaster 90 upgrade
	IC641CTL171K Control 90-70 Programmer Subscription upgrade
	IC641CTL930H Control 90-30 Programmer w/CD Documentation
	IC641CTL931H Control 90-30 and VersaMax Programmer w/paper Documentation
	IC641CTL130H Control 90-30 and VersaMax Programmer Logicmaster 90 upgrade
	IC641CTL990H Professional Developer Package 90-70, 90-30, VersaMax, SFC
	IC641CTL991K Distributor Demo 10 pack
	IC641CTL993K OEM Evaluation Kit – 30-day license
	IC641CTL972H Upgrade to add 90-70 target
	IC641CTL932H Upgrade to add 90-30 high-end and VersaMax target
	IC641CTL937B Programmer Toolkit
	IC641CUG970K Control 90-70 Programmer Upgrade
	IC641CUG930K Control 90-30 and VersaMax Programmer Upgrade
	IC641CUG990K Professional Developer Package 90-70, 90-30, VersaMax, SFC Upgrade

GFK-1578B

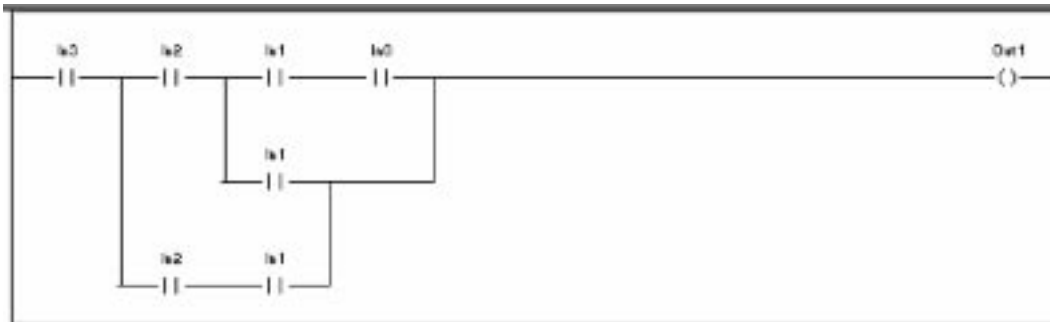
7. **Complex 90-30 Boolean rungs failing on compile.** Some 90-30 complex boolean rungs, such as the one in the following example, fail on compile. The error message “Logic sub-path cannot enter in the middle of another sub-path” is generated.
