# IMPORTANT PRODUCT INFORMATION

| <b>Product:</b> | <b>Control Version 2.30 Service Pack 1 Programmer and Configurator</b> | |

GFK-1882

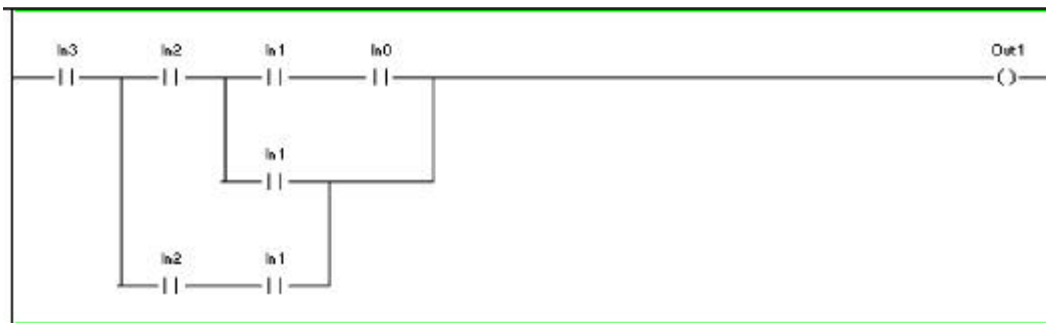
### 7. Complex 90-30 Boolean rungs failing on compile.

Some 90-30 complex boolean rungs, such as the one in the following example, fail on compile. The error message “Logic sub-path cannot enter in the middle of another sub-path” is generated.
